A Preliminary Assessment
of
Chevron U.S.A./Baltimore Terminal
Baltimore, Maryland

Final Report
June 1985

Prepared By: Maryland Waste Management Administration
201 West Preston Street
Baltimore, Maryland 21201

Prepared For: U.S. Environmental Protection Agency
Region III
841 Chestnut Building
Philadelphia, Pennsylvania 19107

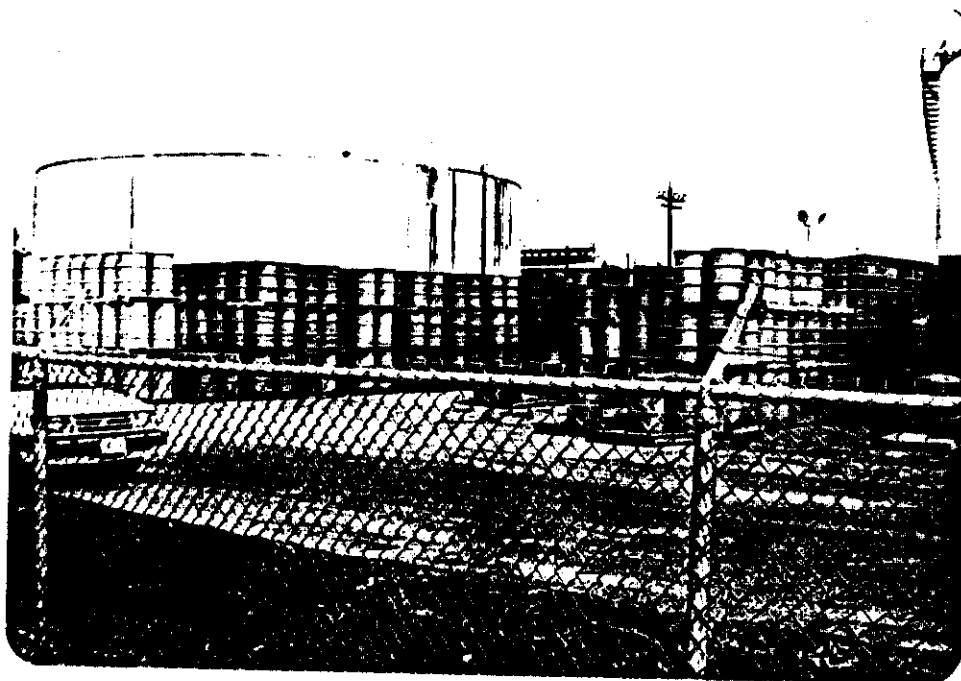
Raw materials are chiefly stored in fifty-five (55) gallon drums in the facility's designated drum storage area near the Terminal warehouse and this area is equally well kept.

Drum storage area in the storage yard containing raw materials and production materials only.

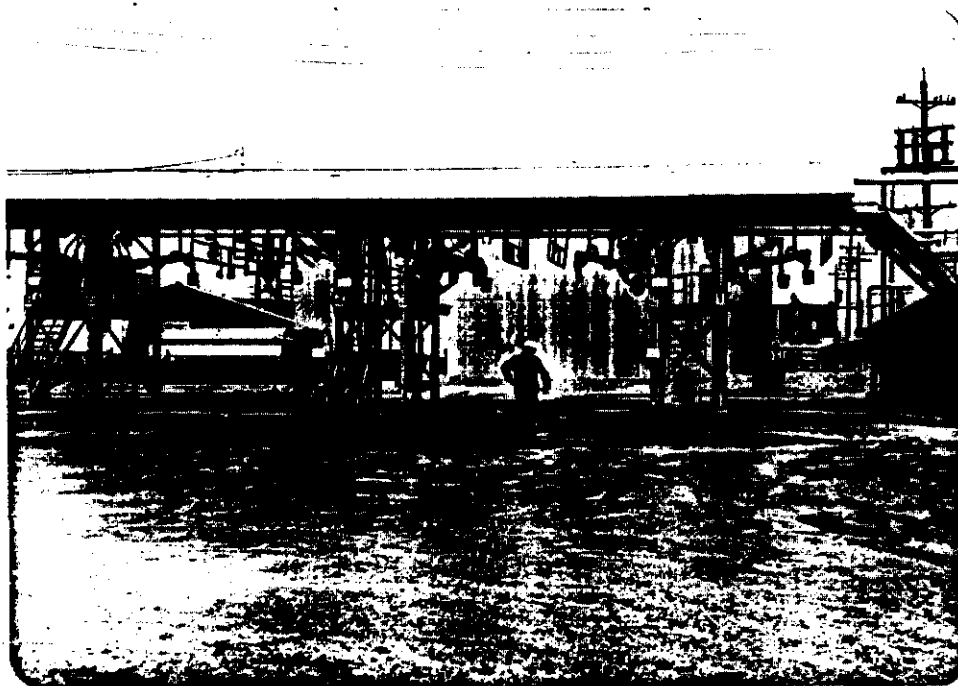
Throughout the remainder of the inspection, the MD WMA personnel found no evidence of any problems. A few of the storage tanks near the boilers and shop areas had some dried asphalt drippings on their side walls, but in general, the plant is maintained in a very clean and orderly manner. Even the truck loading area was observed to be well maintained (See page 30).

Truck loading area located
near Shop area and Engineering
Building: Chevron U.S.A.

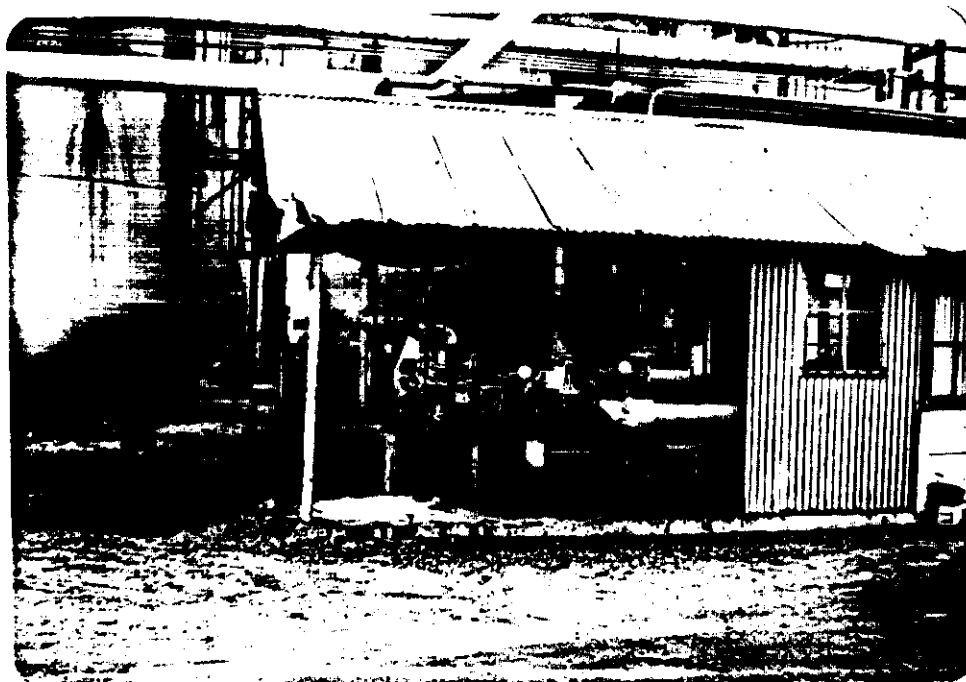
Shop building containing a small
generator: Drip pans pictured at
left of photograph.

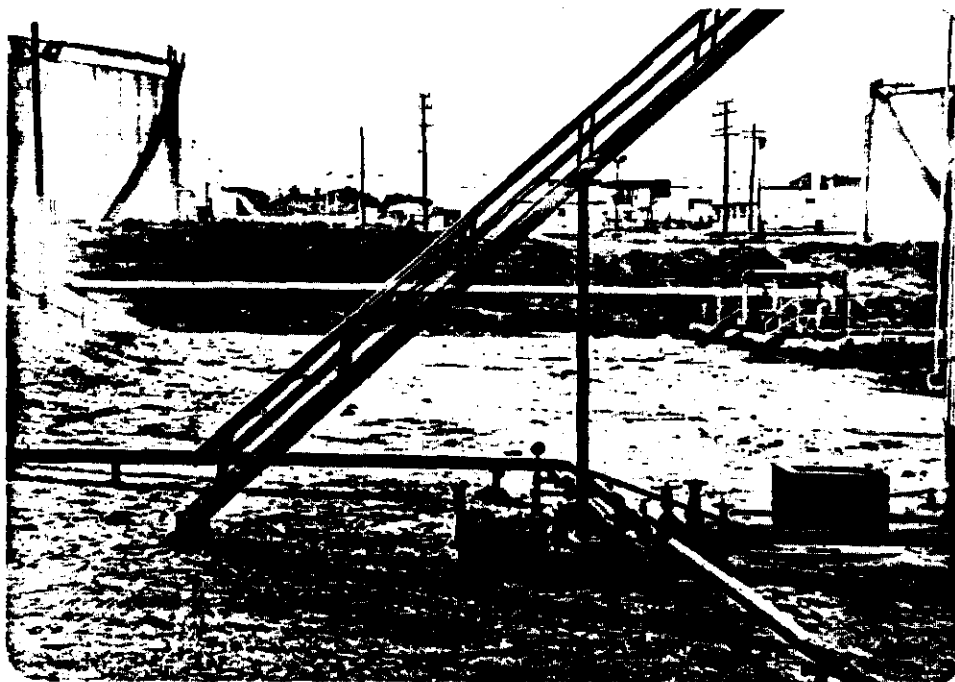
During an interview with the Terminal Superintendent, MD WMA learned that there were, in fact, two leaded tank bottoms on the property on either side of the small paved roadway just south of the District Office Building (See the upper-left-hand quadrant of the enclosed site plan).

Investigation as to the disposition of the two leaded tank bottoms proved fruitless, however. Apparently, the tank bottoms were on the property when Chevron U.S.A. originally purchased the Terminal property from the American Bitumuls and Asphalt Company. According to plant personnel, the tank bottoms were installed some time prior to 1948 in the location previously described. No one at the Baltimore Terminal had any knowledge or recollection of the manner in which the tank bottoms were ultimately abandoned or when the units were buried or removed. The Terminal Superintendent, an employee at this plant for thirty-seven years, could not recall whether the tank bottoms were removed from the grounds or buried in place. The only information available regarding the location where the tank bottoms existed are the comments and descriptions by the Chevron personnel interviewed which gave indications that the grounds in and around the original location of the leaded tank bottoms have been excavated and regraded (See enclosed photographs, pages 9 and 10). No physical evidence of the tank bottoms on-site remains.

View of original site of leaded tank bottom which was formerly located on southwest side of storage tank #23 (See site plan).

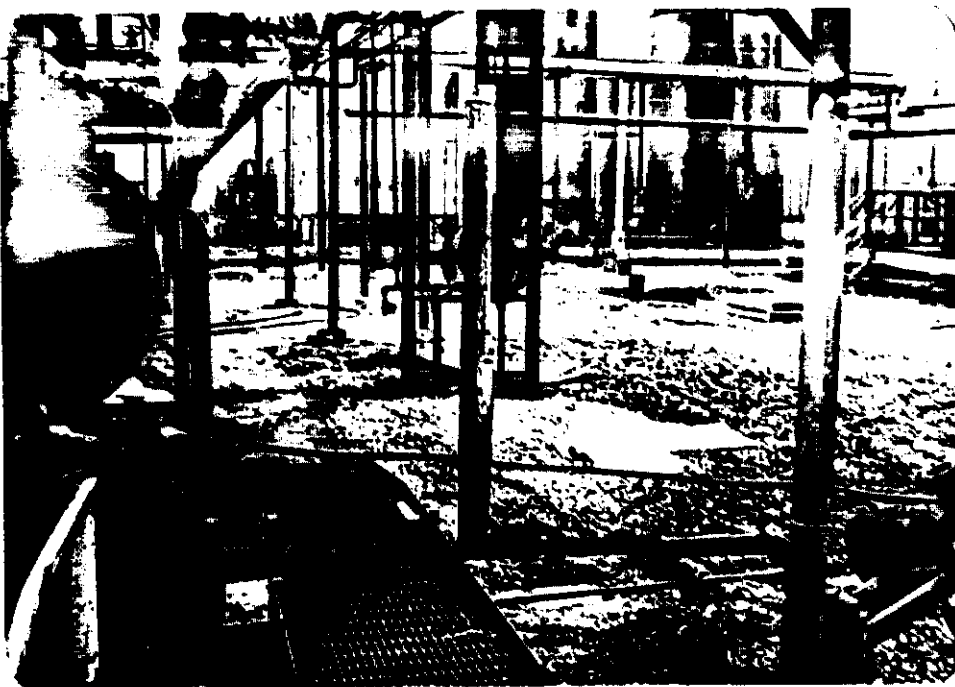
End view of the dryer unit and related associated structures: catwalk and drip pans pictured.
